Unspoiling the environment

Sustainable quarry restoration using colliery spoil extractive waste

By Paul Hubbard, MJCA

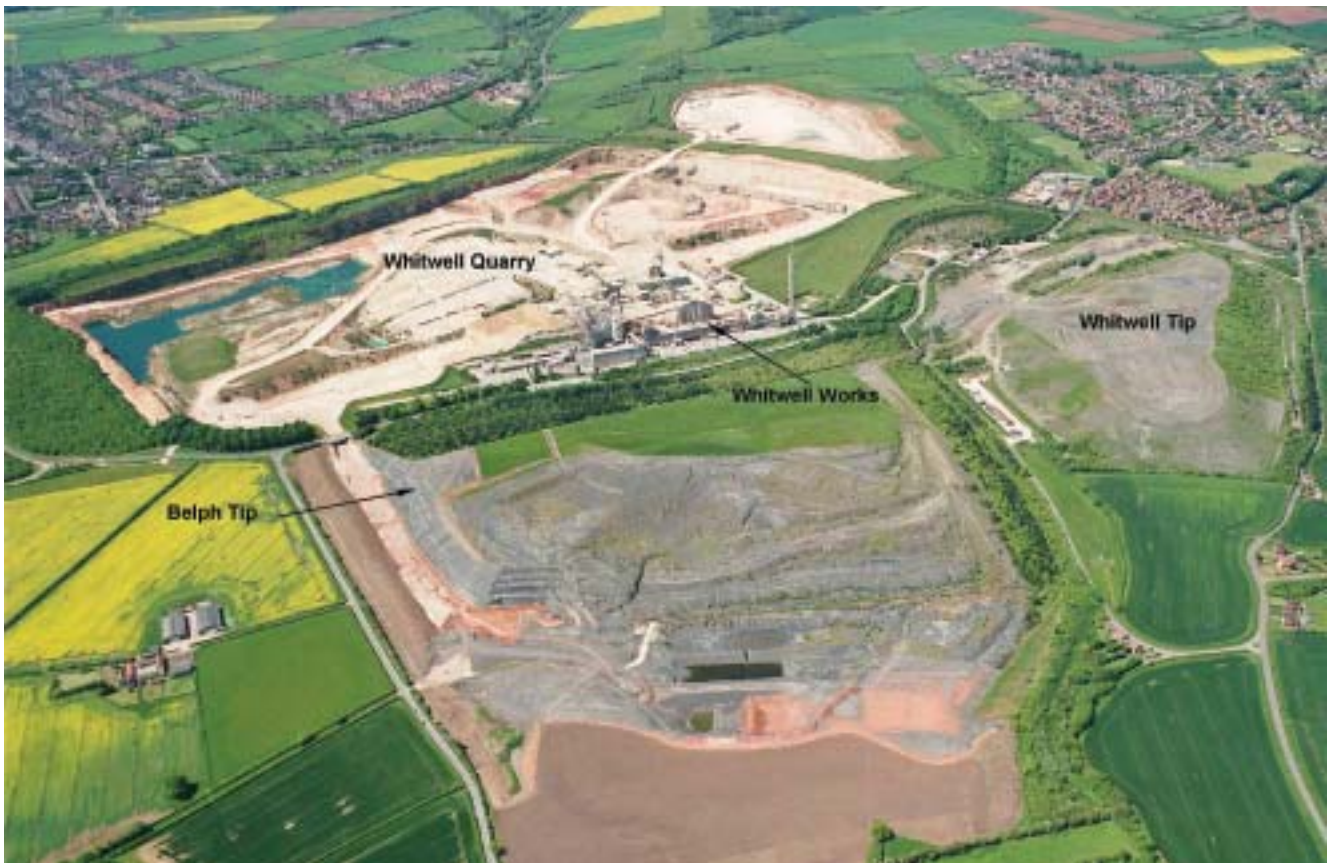
Fig. 1. Aerial photograph (taken in 2009) of Whitwell Quarry and the Belph and Whitwell colliery spoil tips

To the east of Whitwell Quarry lie two large colliery spoil tips from former coal workings in the area which date back to 1894 (fig. 1.). The colliery spoil tips lie open to weathering processes and there is evidence to suggest that, without ongoing long-term management, water draining from the spoil tips has an impact on the quality of the nearby watercourses and underlying groundwater. The tips overlie a part of the dolomitic limestone and prevent access to this valuable mineral reserve. The solution sought was to relocate the spoil from one of the tips, named 'Belph Tip'. This approach would not only allow Lafarge to gain access to the limestone reserves to the east of the main quarry, but would also provide materials that could be used in the restoration of the main quarry and remove one of the spoil tips which currently is affecting the local environment.

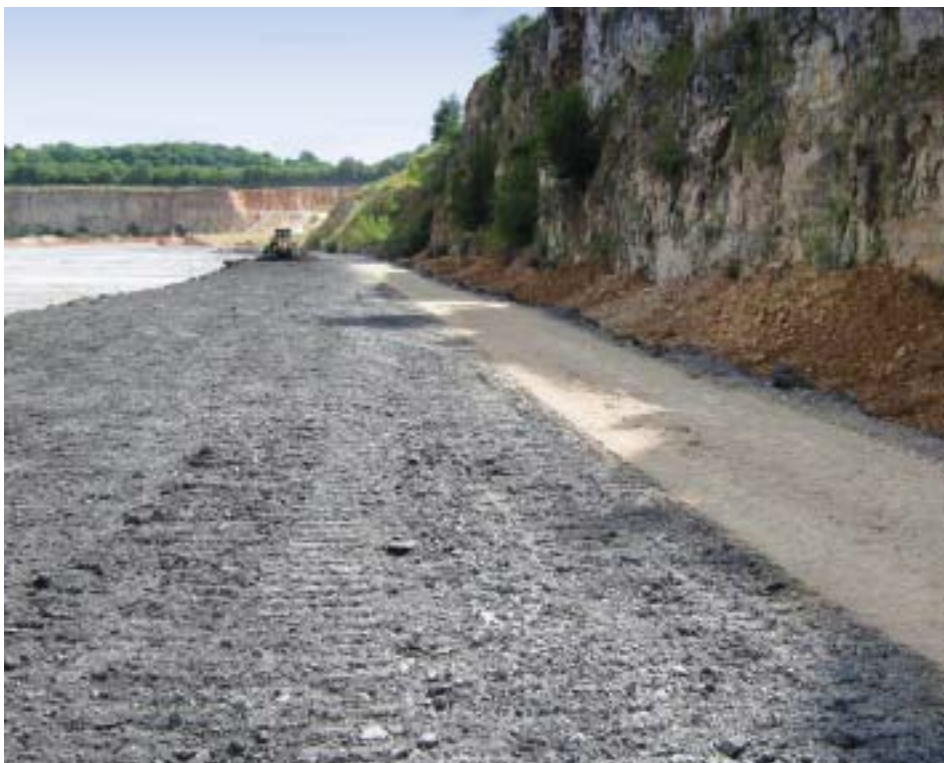
Fig. 2. Mixing of kiln dust and colliery spoil prior to compaction to form the base of the perimeter side wall

The area of the quarry in which the colliery spoil is placed is lined with a 'reactive' perimeter layer comprising a 1m thick layer of the colliery spoil mixed with 5% limestone kiln dust. The limestone kiln dust (also referred to as doloflour) is a by-product of the kiln process at Whitwell Works and was previously has been landfilled at the Whitwell Quarry complex. The proportion of the highly alkaline kiln dust used in the barrier is calculated to ensure that there is sufficient neutralization capacity for the predicted

The construction of the perimeter layer base and the engineered side slopes commenced at the site in 2010 (as shown in figs 2 & 3). The colliery spoil relocated from the tip is mixed with the kiln dust using a rotavator, placed in 250mm thick layers and then compacted. These works are being overseen by geotechnical engineers from MJCA and verified through laboratory testing of core samples taken from the compacted layers for moisture, density and permeability characteristics, and the use of in-situ nuclear density moisture gauge tests to confirm that

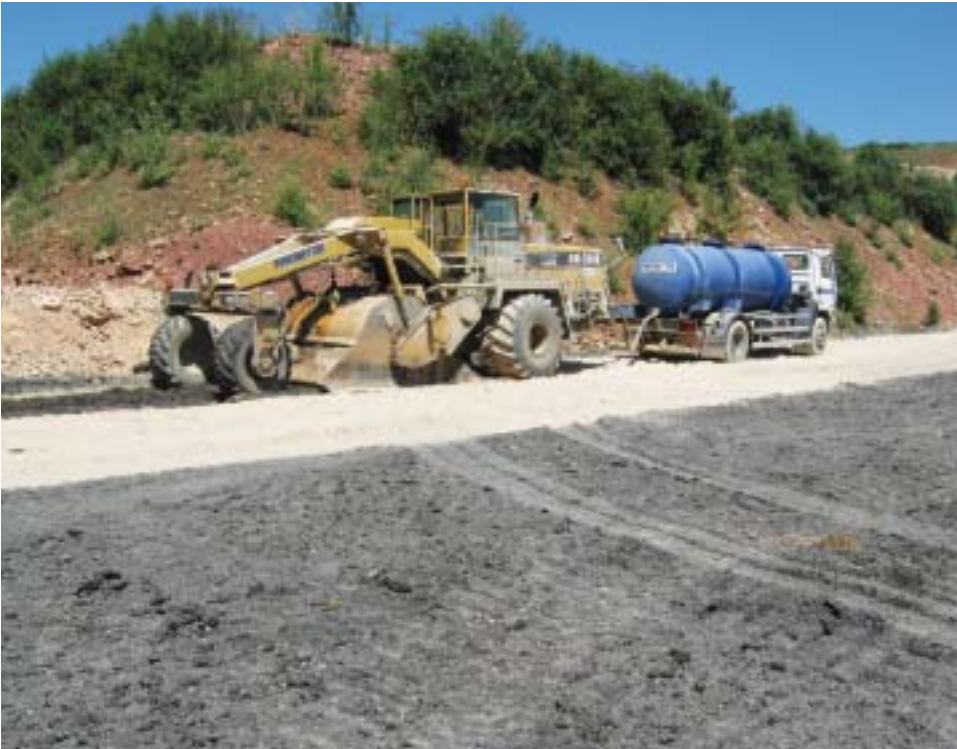
Fig. 3. Rotavator plant mixing a layer of kiln dust and colliery spoil prior to compaction for the formation of the basal perimeter layer
